# Examining the World War II Underwater Cultural Heritage of Maui and Lānaʻi through 3D Photogrammetric Modeling

## ABSTRACT

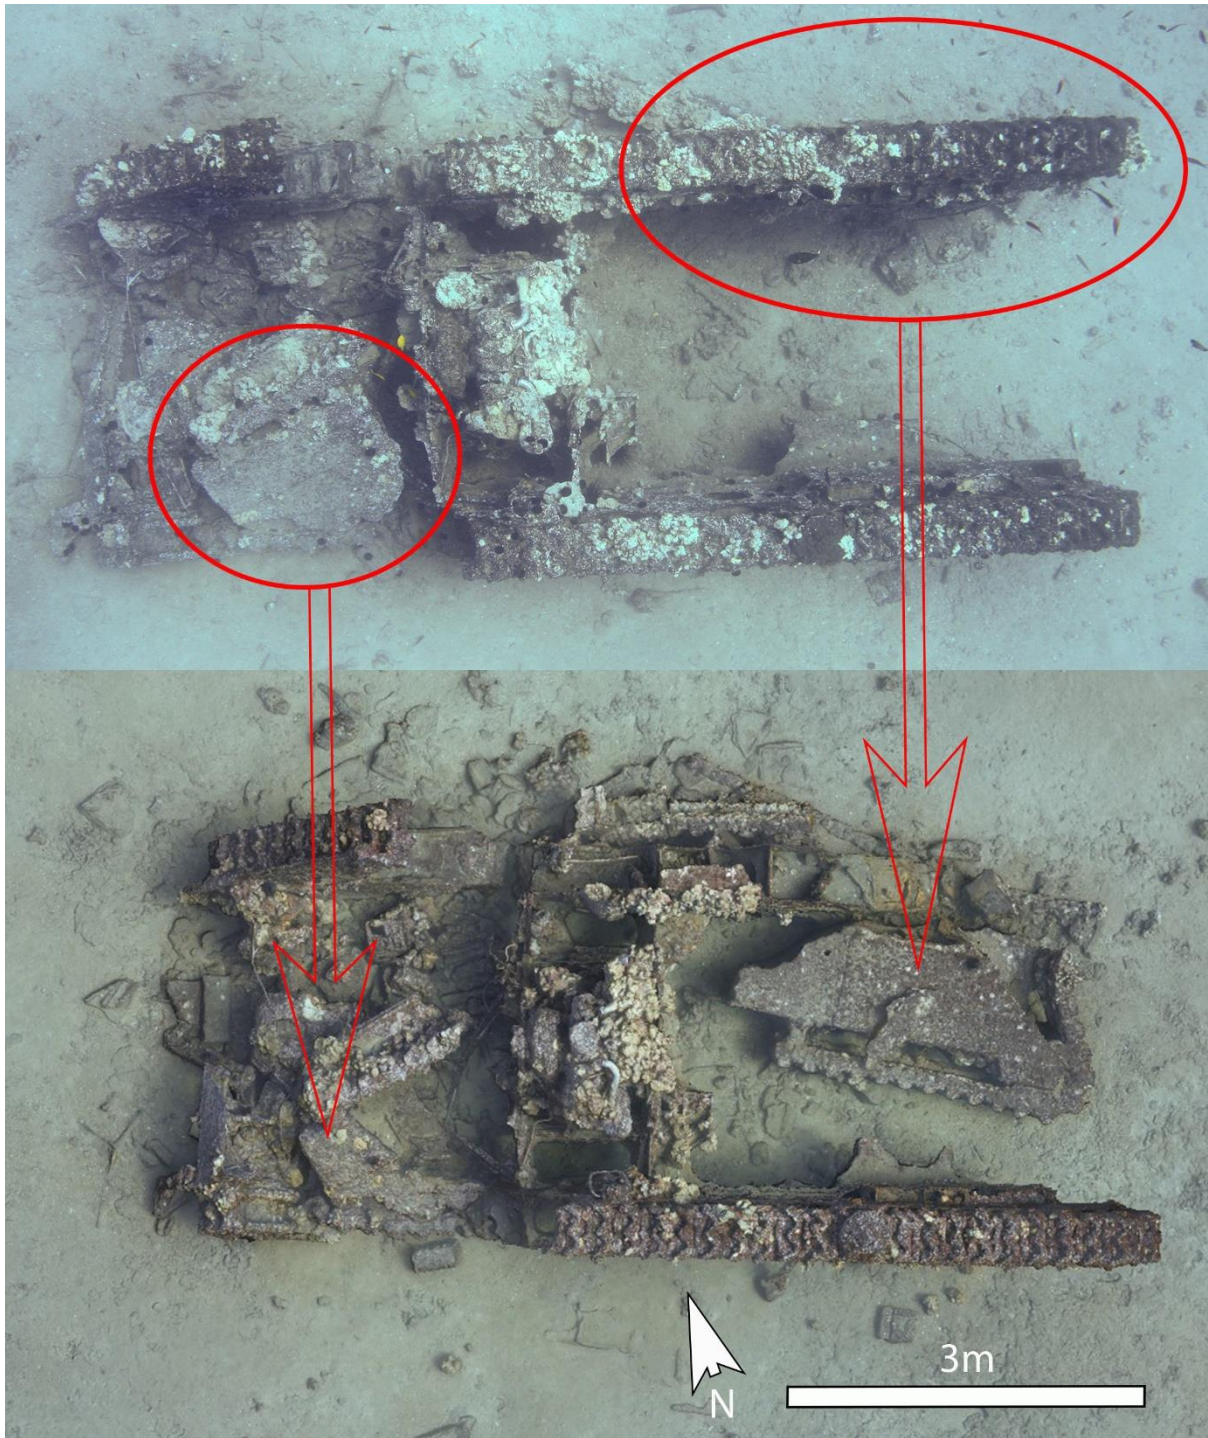
An LVT-4 located off Makena Landing was the first site surveyed (Figure 2). It lies upright on the seafloor at a depth of 18 m, surrounded by a small debris field made up of structural elements and wiring. As was the case for all the LVTs surveyed, much of the vehicle is heavily encrusted in marine growth with pockets of coral concentrations, especially on engine parts. The driver's compartment (cab) has collapsed, exposing the front-mounted engine. The floor of the rear compartment is mostly worn away, apart from a segment on the port side that is noticeably more deteriorated than it was in 2011. A section of the cab plating has also shifted and broken apart. The most significant change in site condition is the complete collapse of the starboard pontoon. Snapped along the bottom front corner, the bulk of this pontoon now lies within the rear compartment.

**Figure 2.** A 2011 photograph of the site (above) juxtaposed over 3D model of Makena LVT-4 (below); damage to pontoon and cab plating indicated in red (Top image courtesy of NOAA ONMS/UH MOP; bottom image courtesy of ECU/UCLA).

According to a local informant (P. Fiene pers. comm. 2022), the pontoon collapsed after the magnitude 6.9 earthquake, which impacted Hawai‘i in 2018. This tectonic event and over a decade of storm events have affected the site by increasing debris strewn around it.

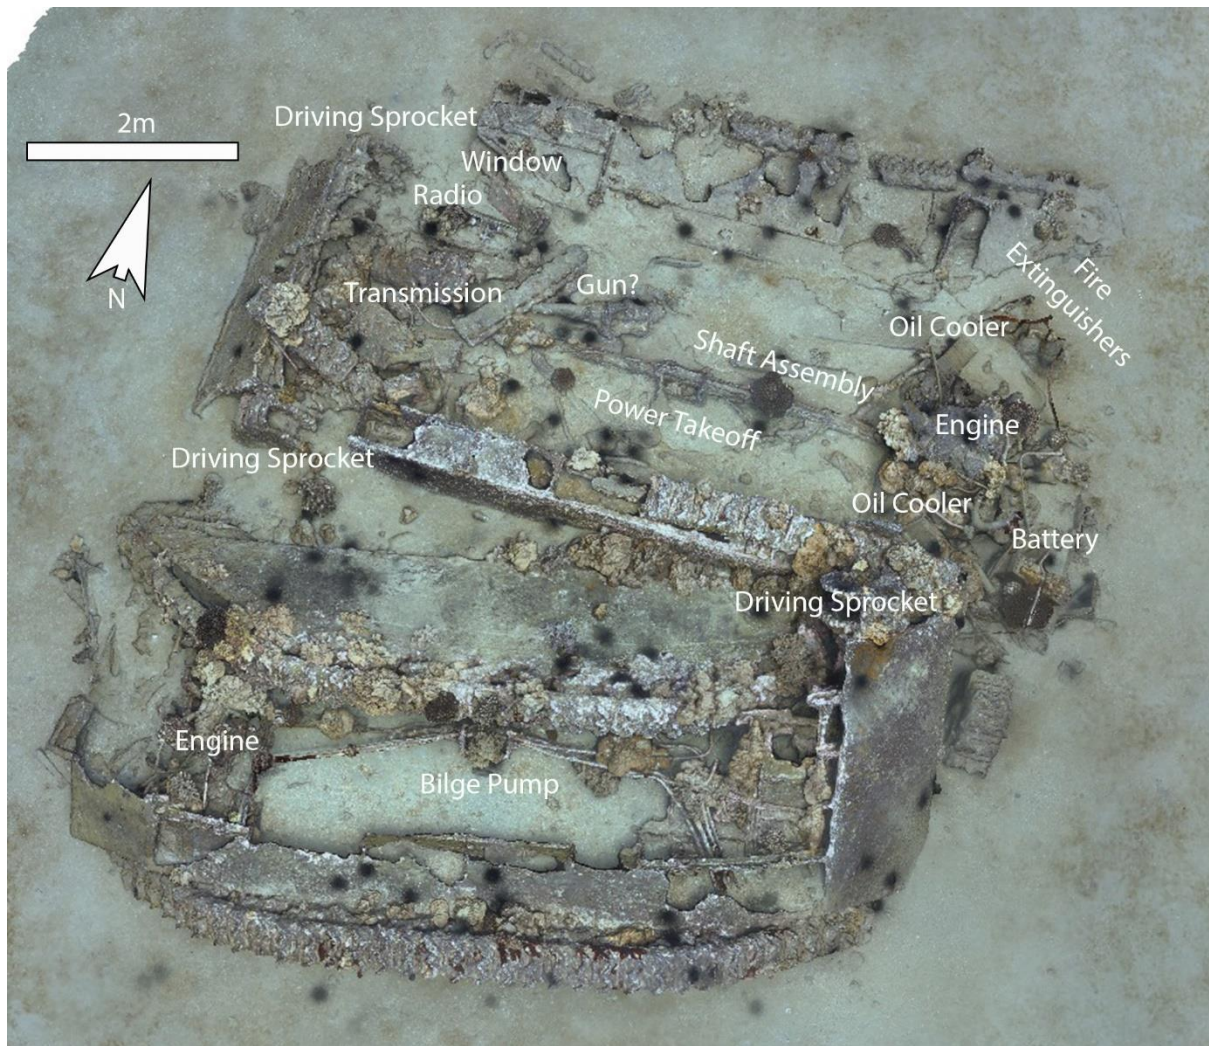
Project team members were alerted by a local consultant of the remains of an unrecorded site located within Mā'alaea Bay. As this site is not currently included in the state database, information related to its position is withheld until it can be properly assessed for management purposes. The site consists of two, abutting LVTs (Figure 3). Based on the rear engine configuration, dimensions, and presence of a small glass window (55 centimeter (cm) -x-40 cm), both vehicles are tentatively identified as being LVT-2 types (Mesko 1993; US War Department 1944). The first LVT-2 has its bow pointing west and sits upright. Its starboard pontoon has collapsed and lies on the seafloor, with some pieces of track still attached. The port pontoon remains intact and standing, though most of the track has broken off and is scattered around the wreck. The bottom third of this pontoon appears dug into the sediment. The coral encrusted rear-mounted engine is clearly visible and is connected to the front transmission via a propeller shaft. The midpoint of the shaft is connected to a power takeoff that leads to a buried bilge pump. The hull floor cannot be discerned as it is covered by sediment overlaid with debris. Near the engine, identifiable components, including both oil coolers, the portside battery, and fire extinguishers are evident. Toward the bow, in the vicinity of the transmission, appears to be the vehicle's radio, side window, and possibly one of its guns. Forward of this area are the driving sockets, which have collapsed and remain partially buried.

**Figure 3. 3D model of previously unrecorded LVT-2 wrecks in Mā'alaea Bay. Identifiable components are labeled (courtesy ECU/UCLA).**

The other LVT-2, with its bow pointing east, is situated upside down. Listing towards its port side, the bow (driving socket and front hull plating) is propped up by the adjacent vehicle on its starboard side. The starboard pontoon has collapsed inwards, following the direction of the list. The track and grousers on both pontoons are in relatively good condition. Much of the floor hull plating, extending from the engine compartment, up to the driving sprockets has deteriorated. This has exposed the bottom of the engine compartment, though the top half of the engine itself remains buried. From the engine, various pipes and tubing, some of which are related to the bilge pump at the hull's floor, run along the vehicle's centerline and terminate just aft of the driving sockets.

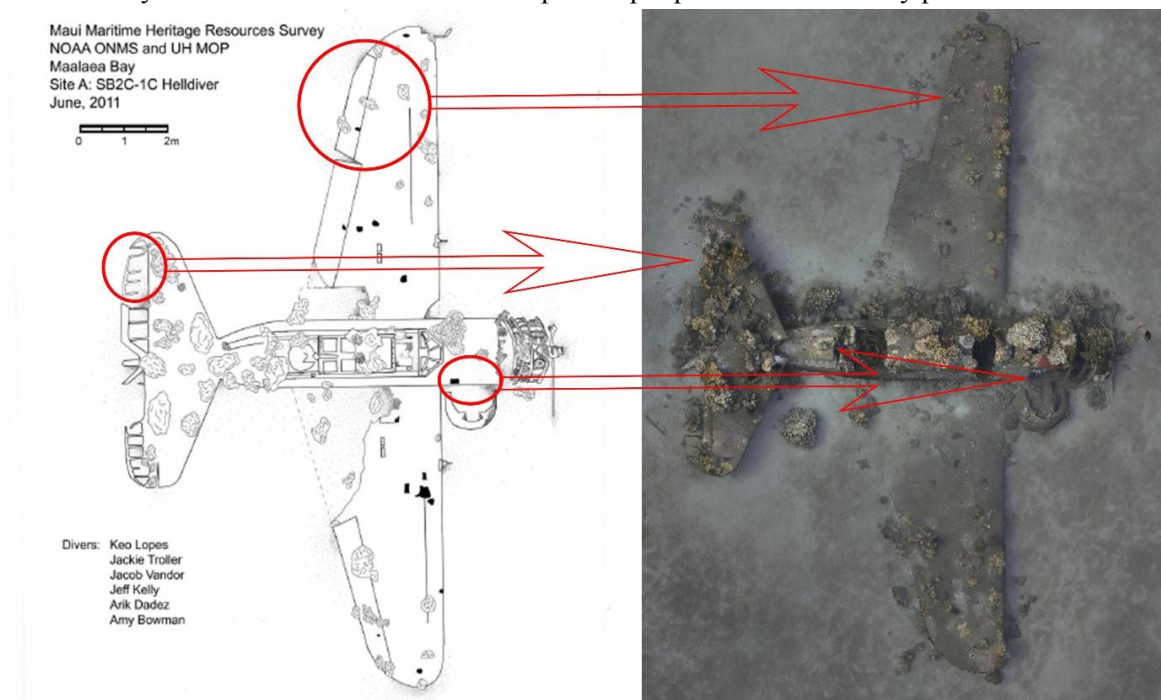
In the middle of Mā'alaea Bay lies an almost fully-intact Curtiss SB2C-1C Helldiver (Figure 4). The aircraft's structural completeness made its identification fairly easy (ONMS 2011). Its engine has slightly broken off from the airframe and the cowling rests on the seafloor to the starboard side. The vertical tail stabilizer is also detached and partially buried aft of the wreck. Since 2011, the Helldiver has remained in relatively good condition. The most notable changes include the collapse of the port wing aileron, and the dislodgment of an aluminum panel on the starboard side of the nose, exposing the engine bearing struts. Minor damage has occurred to the plane's tail, where part of the elevator's portside framing is now missing. After its discovery in 2010 by a local dive operator, the Helldiver's Bureau Number (184000) was identified on the detached vertical stabilizer. The ONMS (2011) website provides a description of the crash incident, which along with the subsequent rescue of the pilot and radioman, explain the missing rescue raft and the open position of both canopies. The aircraft's story is now memorialized on an interpretive plaque that was recently placed at the site.

**Figure 4. 3D model of Helldiver site (right) compared with 2D site plan (left) (courtesy NOAA ONMS/UH MOP)**

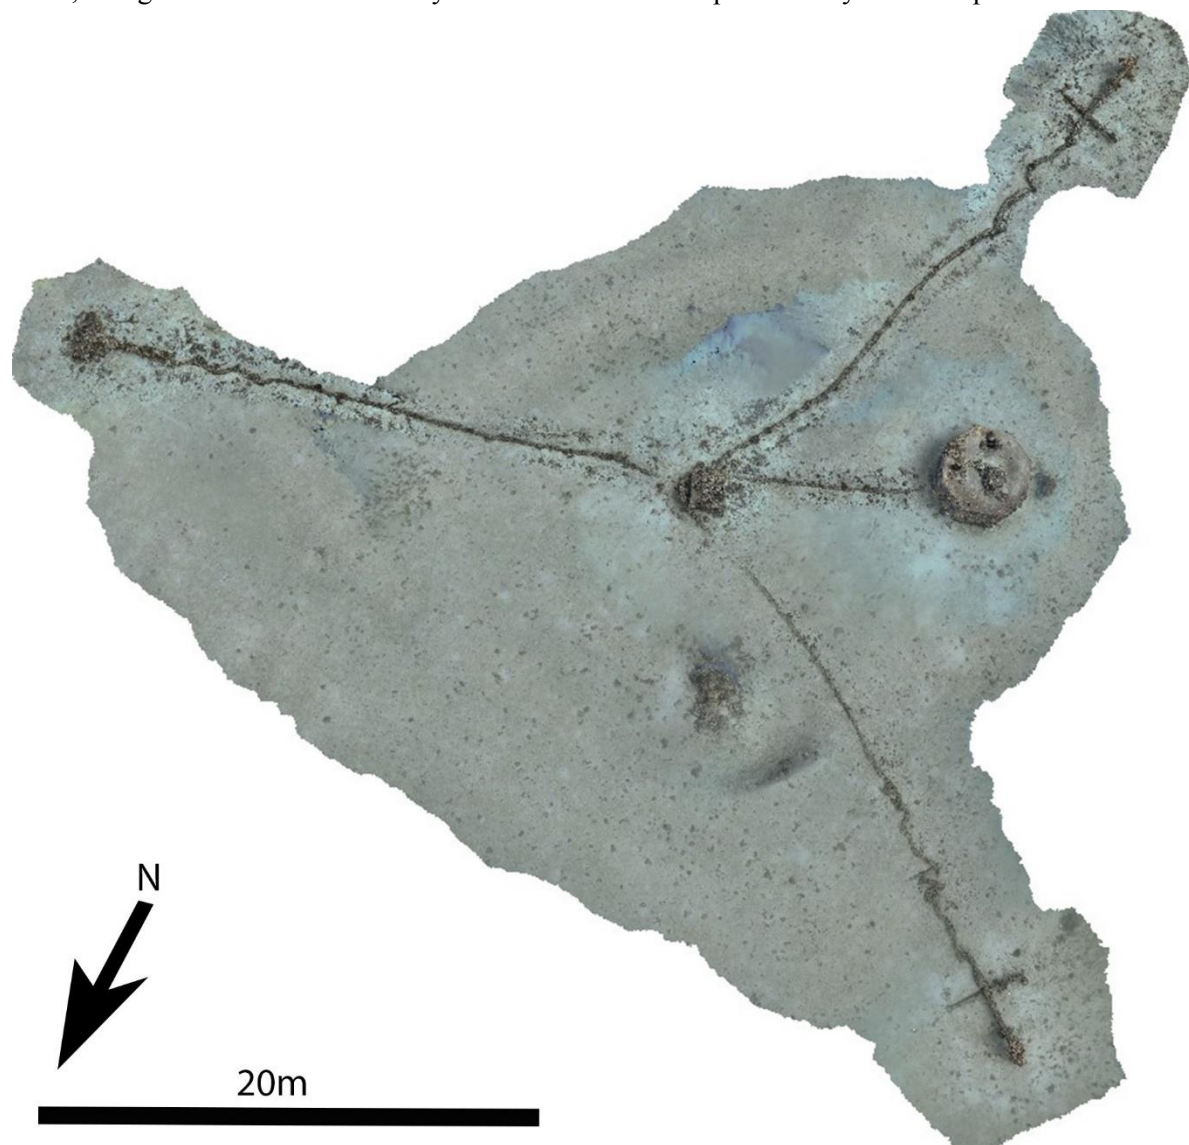
Known locally as “Three Anchors”, a naval mooring is found 1 kilometer (km) off Lā‘ie Beach, near the Mā‘alaia Bay Hellcat site (Figure 5). This location has become a recreational diving destination, due to an abundance of marine life attracted to it. The site consists of two large admiralty anchors and one US Navy (USN) stockless anchor that are all chained to a central cement block. The block is chained to an octagonal, hollow concrete mooring buoy, which is thought to have supported a naval degaussing station (Settle-Chesser n.d.). The station itself was located 2 km to the northeast, currently the site of the ONMS Visitor Center in Kihei (ONMS 2009). This site was not surveyed in 2011 or 2013, though it has been recorded by others and is featured prominently on dive operator websites.

Figure 5. 3D model of “3 Anchors”, a WWII era USN mooring (courtesy ECU/UCLA)

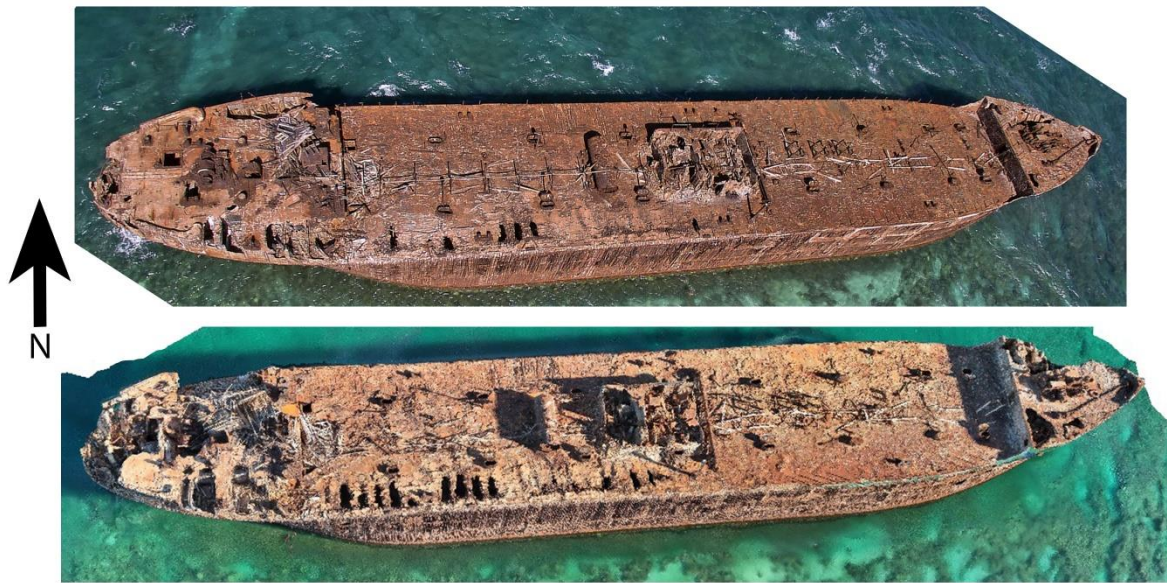
**Figure 6. Earlier photo of YOGN-42 (above) compared with 3D model of YOGN-42 (below) (Top image courtesy of R. and K. Brooke n.d.; bottom image courtesy of ECU/UCLA).**

Immediately, it was apparent that the ship's decks were becoming increasingly compromised. Deck plating on the starboard quarter of the main deck has disappeared, exposing underlying deck beams. A similar observation was made for the starboard side of the forecastle deck. More concerning is the near-total collapse of the ship's quarterdeck. Deck plating in this area, beside the footprint of the former pilothouse, is almost non-existent. A large mechanical piece (perhaps a towing winch) once supported by the quarterdeck, has fallen through to the underlying hold and much of the deck's concrete sides have broken off, exposing rooms and bulkheads. A large section of the forecastle deck on the portside has also weathered away, exposing support stanchions. This area is likely to further undergo collapse, as the ship's windlass and anchor chain sit precariously on the crumbling deck.

Changes such as these are important to monitor for safety reasons, as snorkelers and divers are drawn to both the wreck and the marine biota it supports.
