# **Investigating the causes of deterioration and the appropriate conservation treatment method of an excavated wooden schooner found in coastal area of Bangladesh**

Rokonuzzaman S (Dept. of Conservation Laboratory, Bangladesh National Museum)  
[smrokon.chem@gmail.com](mailto:smrokon.chem@gmail.com)

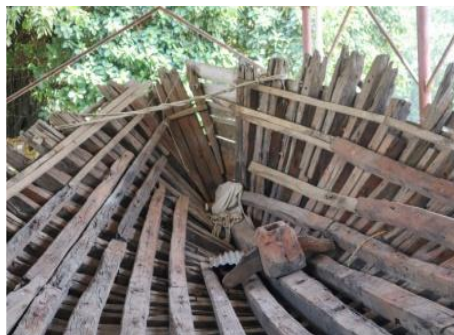
On site inspection, the mentioned problems have been found in the different parts of the waterlogged wooden schooner. The water has removed freely from waterlogged wooden parts in uncontrolled drying. But there has not been any conservation measures of the schooner. As a result, the wood fibers have compressed and the whole structure has converted into a distorted shape (Figures 1.1).

**Figure 1.1: Disfigured structures of the schooner**

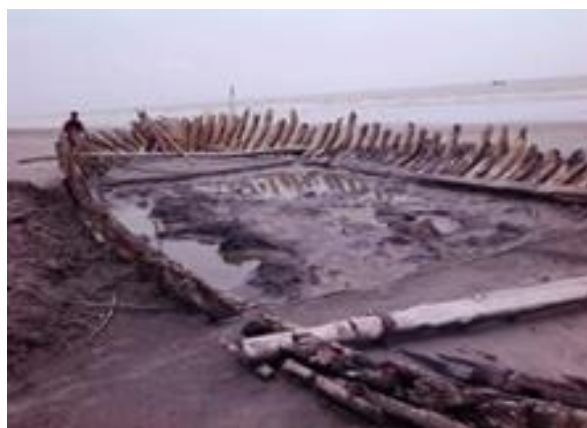
As mentioned earlier, the schooner was left for long periods in different environments such as soil or water, underwent extensive decay and its strength was severely reduced. The various parts of the schooner were closely observed during the onsite inspection. At that time the original wood was missing from some parts of the schooner.

**Figure 2. Excavation of shipwreck**

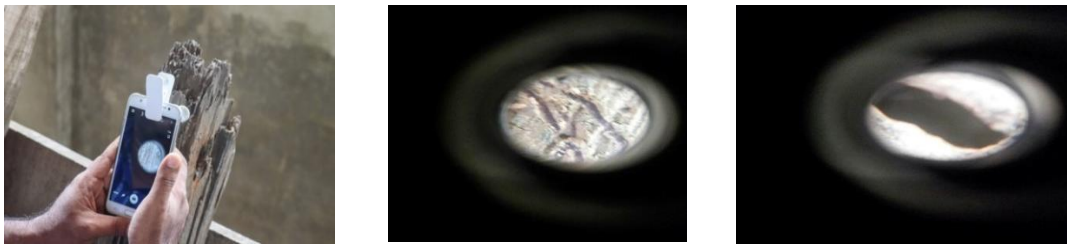
A few places on the schooner, examined under a small microscope, showed extensive white coating on the surface of the wood (Figure 3). Despite several attempts with water, the white spots could not be completely removed. These appear to be salt deposits. It is possible to remove all these white coatings and other impurities by applying water to waterlogged wood for several years.

Figure 3: Microscopic observations
