# The Lashings and Knots of the Chau Tan Shipwreck

Ian McCann

The Chau Tan shipwreck is the oldest ocean-going cargo ship yet found in Vietnam dating from around the 8th-9th century CE. It provides a unique opportunity to study the construction methods of a lashed- lug ship from that period. Over 40 of the ship's timbers were retrieved but unfortunately all the lashings connecting the lugs were severed during the salvage and no record was made of the salvage. There was still enough in situ ropes to start to build a small list of the types of simple knots and complicated flat braided lashings that were used in its construction. For this paper ropes were made using simple technology that may have been available at the time the ship was built. The two knots used on the Chau Tan ship are widely used, even today. The braided lashings are a different matter, they do not appear in any maritime archaeology or sailing literature that the author could access. First the author had to work out how the lashing was tied. It was then tested for strength to try and further understand its utility. The results were surprising and emphasised the value of experimental archaeology.

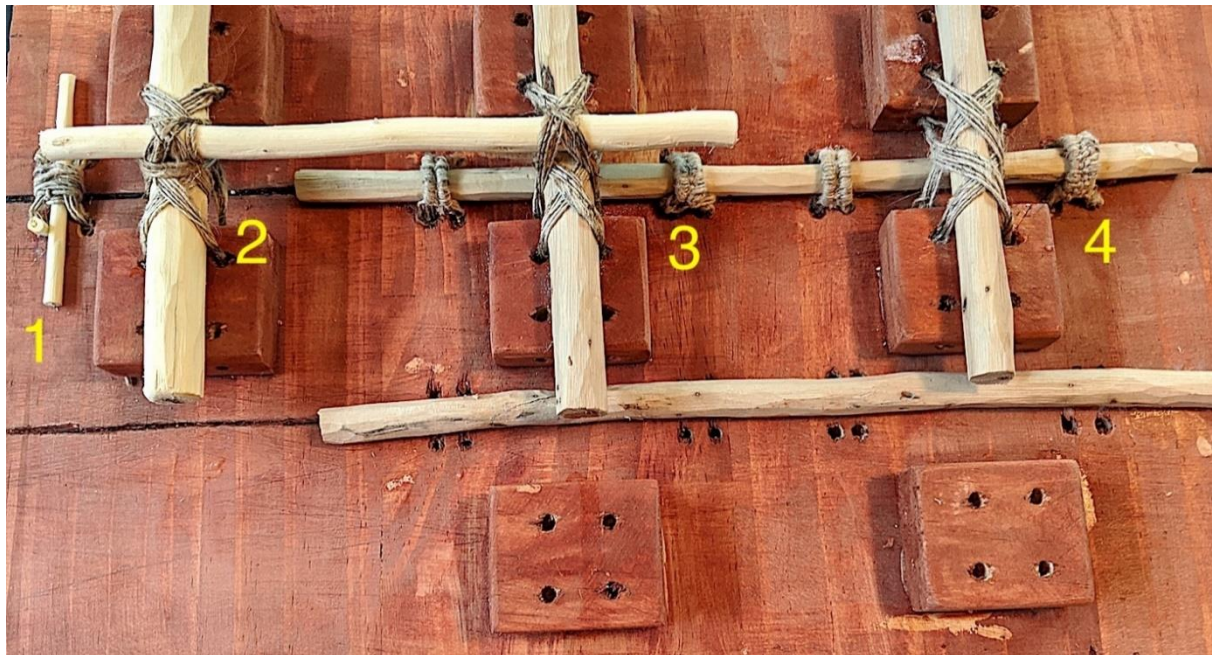
**Figure 3. Lashing model of some of the Punjulharo lashings (1 and 2) and how the Chau Tan stringer or batten may have been lashed (3 and 4). (Model and photo by the author).**

This is a unique feature of the Chau Tan vessel; other lash lugged vessels have longitudinal stringers sitting on top of the ribs or frames leaving a gap between the stringer and the hull planks. As an intact internal structure from the Chau Tan shipwreck does not exist it is not known if the timbers were stringers or if they serve different functions. Figure 3 is a photograph of a model with a combination of lashings from the Punjulharo boat (1 and 2) with the large frame sitting across lugs and the stringers on top of one of the large frames (Lacsina 2016, 130; Mochtar 2018, 52). The small lashing (1) is securing a small batten that is at 90 degrees to the joins of the hull planks (Manguin 2019, Figure 7, Mochtar

2018, 58). Three and four show how the Chau Tan stringers might have been placed under the frames, between the lugs and in direct contact with the hull planks seams.

The small lashing (Figure 3, 1) has some of the same physical characteristics as the Chau Tan lashing. Two bundles of loops are threaded through opposite holes on opposing planks. These bundles are then bound together with another rope that passes over a small batten with a continuous loop. The batten is sitting across the hull plank seam and its purpose is to provide a physical link between the two hull timbers and hold them tightly together at that point.

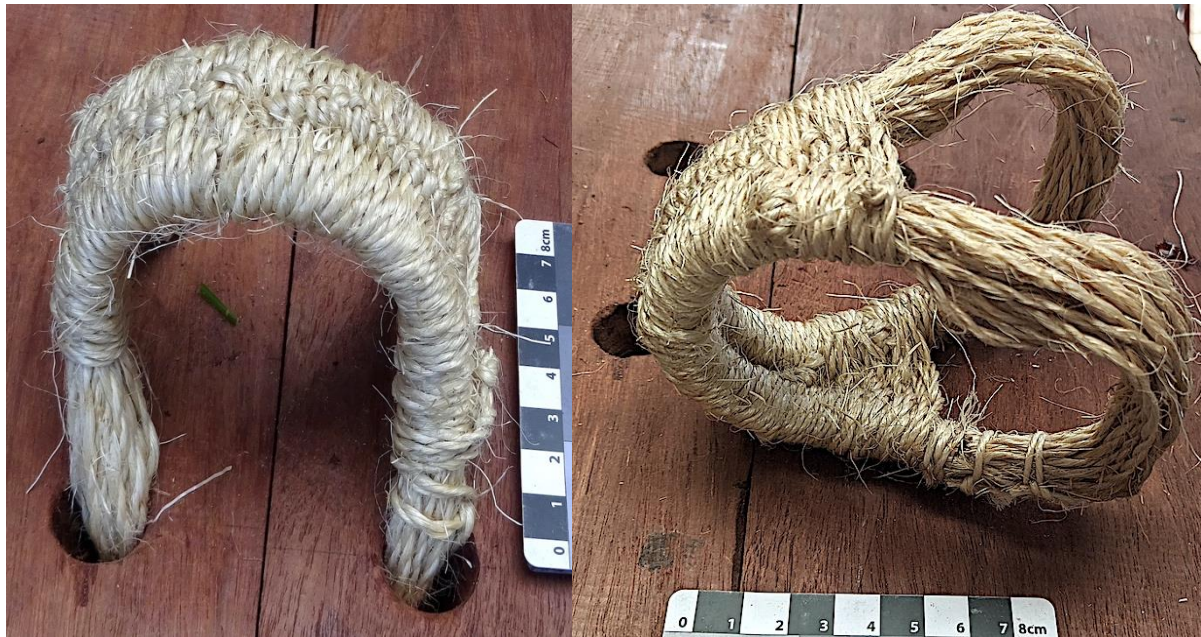
Figure 4. Figure 4. Lashing after the stringer was removed and after the lashing was removed from the through holes.

The stringer could now be slid out from the lashing, (Figure 4 left) and by cutting two of the bundles of loops the whole knot could be removed from the model (Figure 4 right). This allows the structure of the knot to be clearly seen.
